## STREET SWEEPER

## **EFFICIENCY STUDY**

Town of Mammoth Lakes

SATTERFIELD & ASSOCIATES

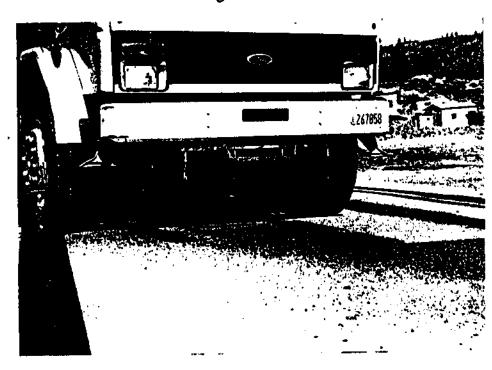
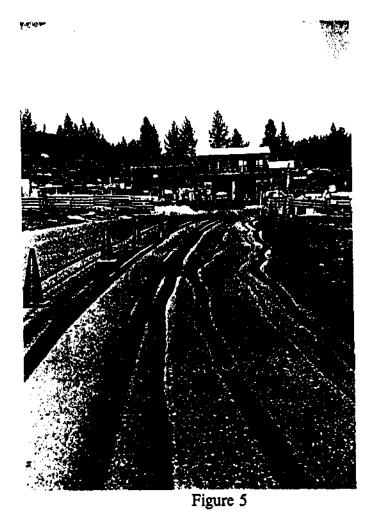
Figure 6

During the same day and the 5 day tests, visual observations were made on the street sweepers operation. These were taken so recommendations could be made that could improve the operation efficiency. Figures 5 and 6 show the typical operation of the street sweeper.

As seen in Figures 5 and 6, the street sweeper did not have an even distributed water spray coming from the spray bar in the front of the machine. This had the effect of over watering one area and not watering other areas. This resulted in the creation of a mud strip down the street as the machine passed. This mud area contained a lot of the fines that the street sweeper was not able to remove from the street. After the mud strips dried the fines were then available to become road dust.

A large amount of the fines that were left behind by the street sweeper were contained in the over watered strip that was left as a result of the uneven spray bar water distribution. These stripped areas became dusty as soon as the strips dried.

- 1. Modify the street sweeper spray bar so that it can deliver an evenly distributed spray. This will decrease the over watered stripes and increase the machines efficiency in removing the PM<sub>10</sub> size particles.
